MD146 over Overshot Run

MARYLAND INVENTORY OF HISTORIC BRIDGES  
HISTORIC BRIDGE INVENTORY  
MARYLAND STATE HIGHWAY ADMINISTRATION/  
MARYLAND HISTORICAL TRUST

MHT No. BA-2791

SHA Bridge No. 3306 Bridge name MD 146 over Overshot Run

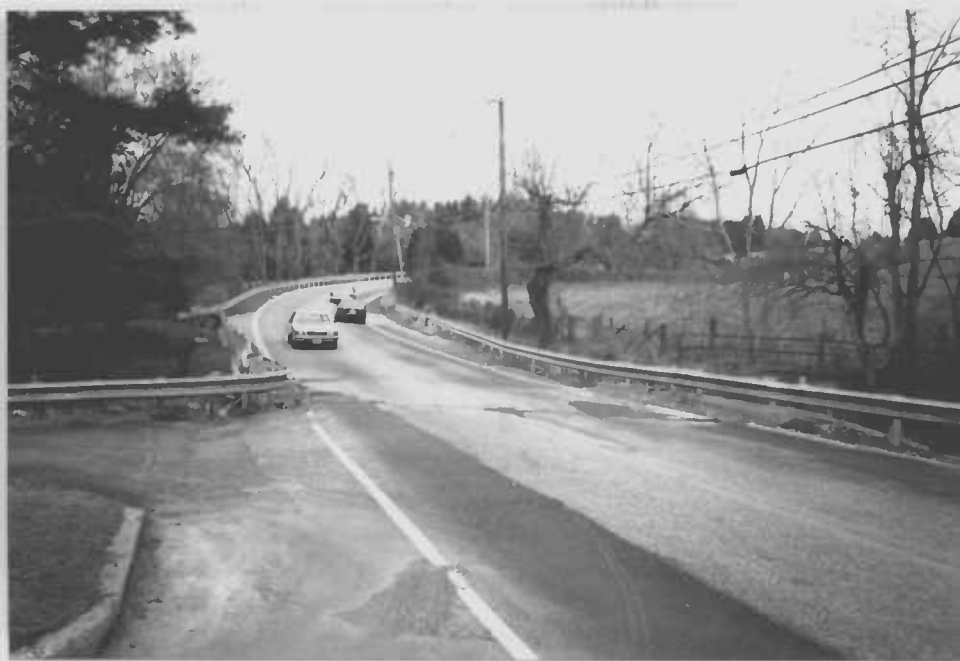
1. BA-2791
2. MD 146 over Overshot Run
3. Balto Co MD
4. Eric Griffiths
5. 3/97
6. MDSHPD
7. east elevation of bridge
8. 4 of 6

According to the 1996 inspection report, this structure is in fair condition with moderate amounts of rust on the girders. The concrete abutments have moderate erosion on the faces with fine to 1/16-inch irregular cracks.
